Preliminary Report on Florida Hyperbaric Chamber Fire

Date: June 9, 2009

Prepared by: Robert B. Sheffield
Chair, UHMS Safety Committee

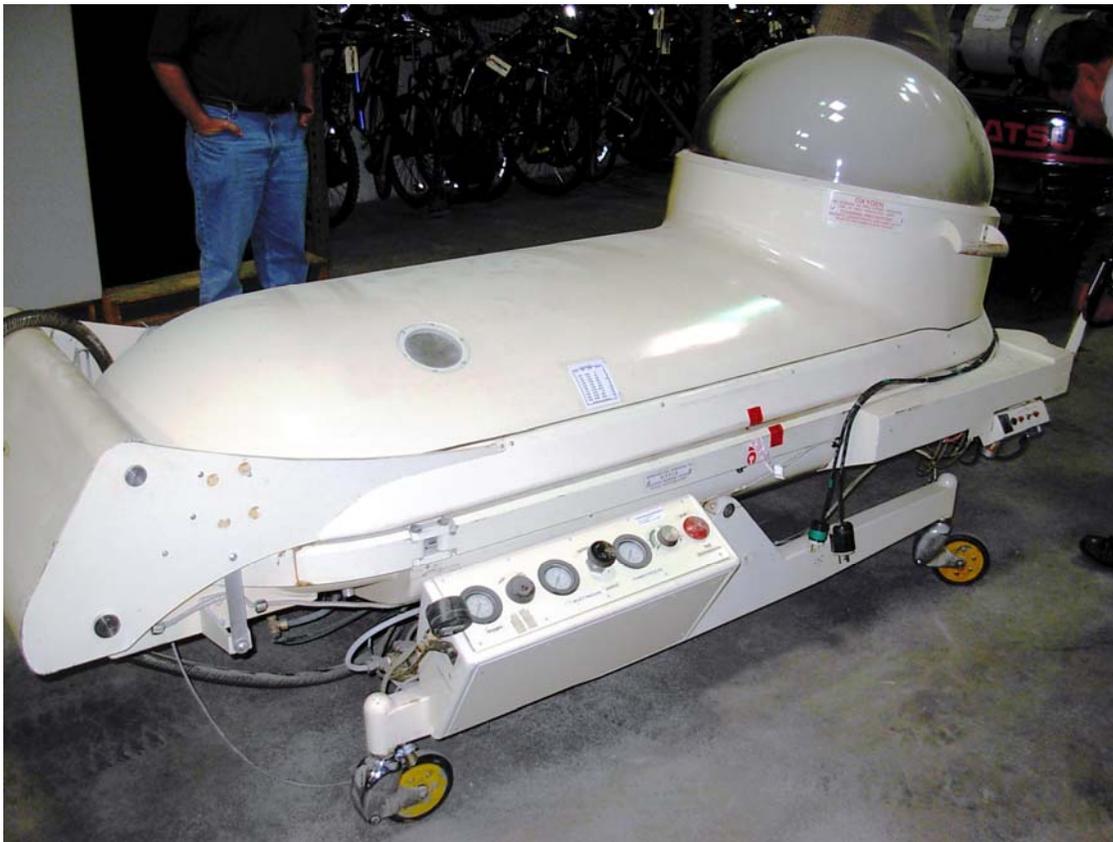
Figure 1: Exterior of Vickers 'clamshell' chamber with lid closed.

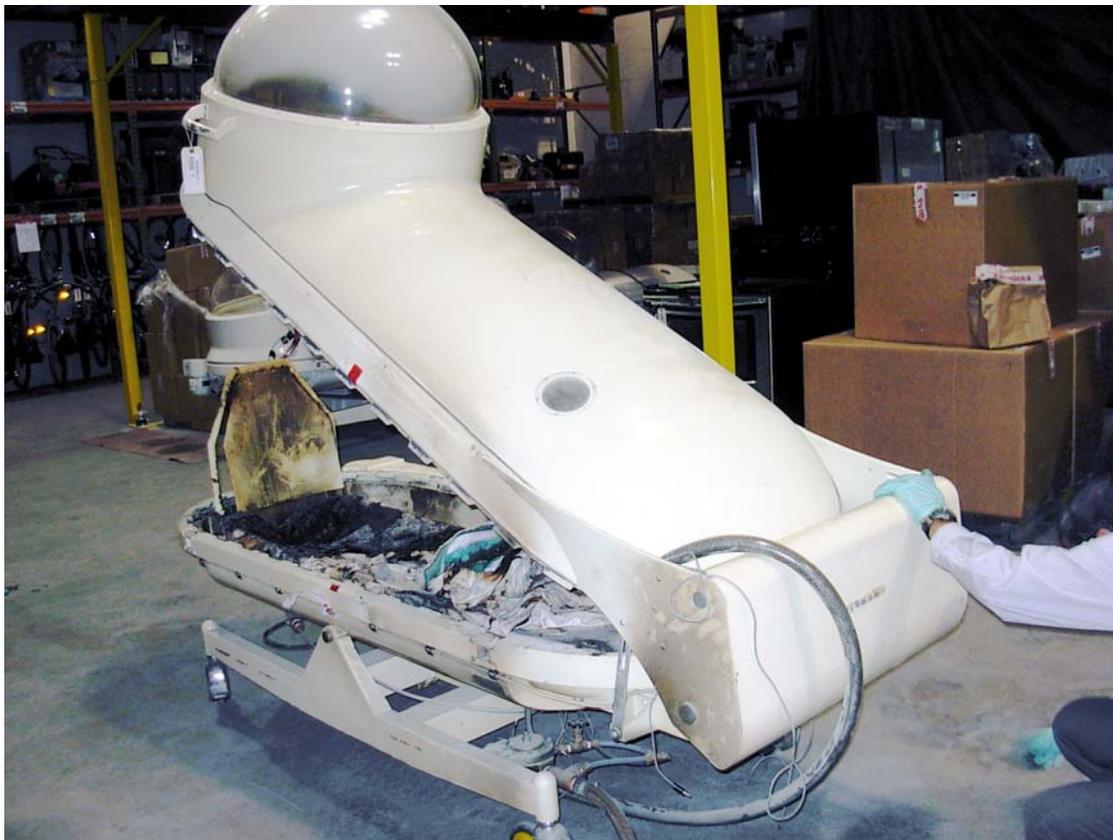
Figure 2: Exterior of Vickers 'clamshell' chamber with lid open.

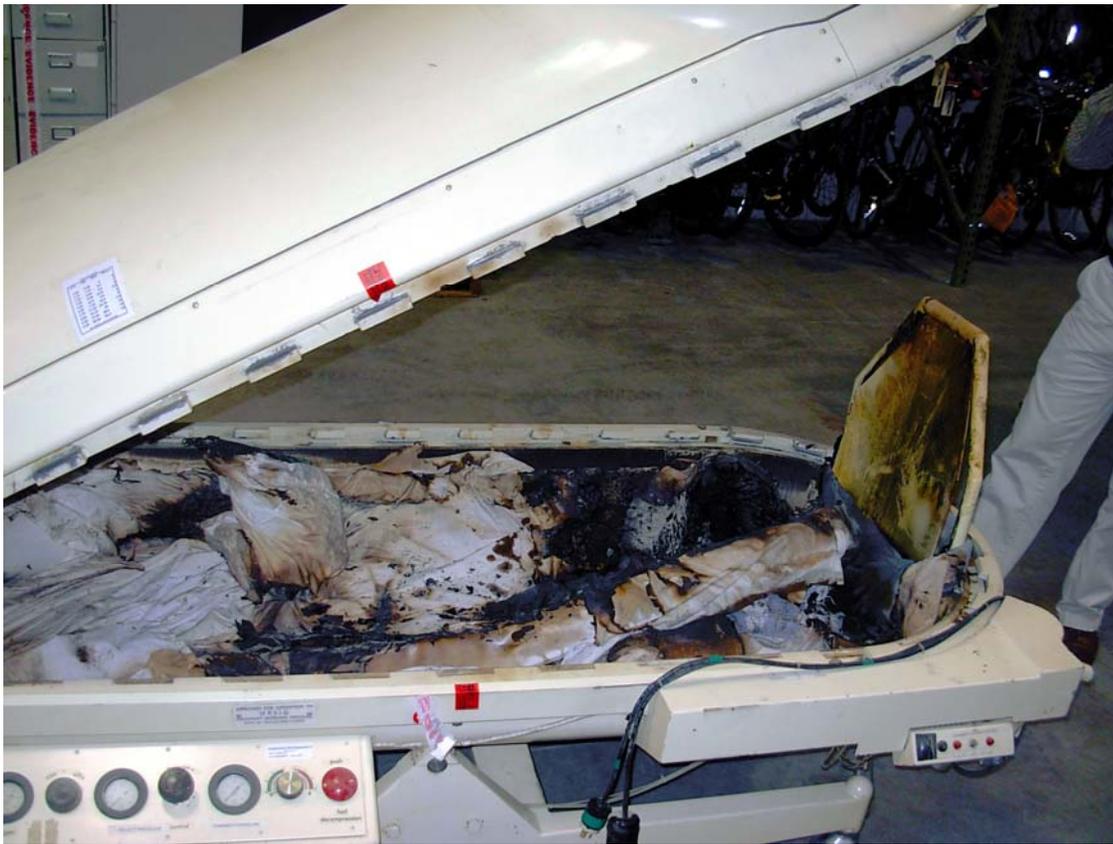
Figure 3: Interior of Vickers 'clamshell' chamber. Approximately $\frac{3}{4}$ of the head end of the chamber interior is visible.

The cause of ignition has not been determined. According to the investigators, inspection of the burn patterns in the chamber suggests an internal speaker as a possible source, but this has not been confirmed. Investigators found that all clothing and linens in the chamber were either cotton or a cotton/polyester blend. Investigators did not find any matches, lighters, warmers, or electronic devices in the chamber or on either of the occupants. The investigation is still ongoing.
